THIRD ENDORSEMENT on NAF MONTEREY AAR 2-58 concerning SNB-5,  
BuNo. 39908 accident occurring 18 September 1958, Pilot MURRAY

AAR 2-58

## AIRCRAFT ACCIDENT REPORT

PART V THE ACCIDENT

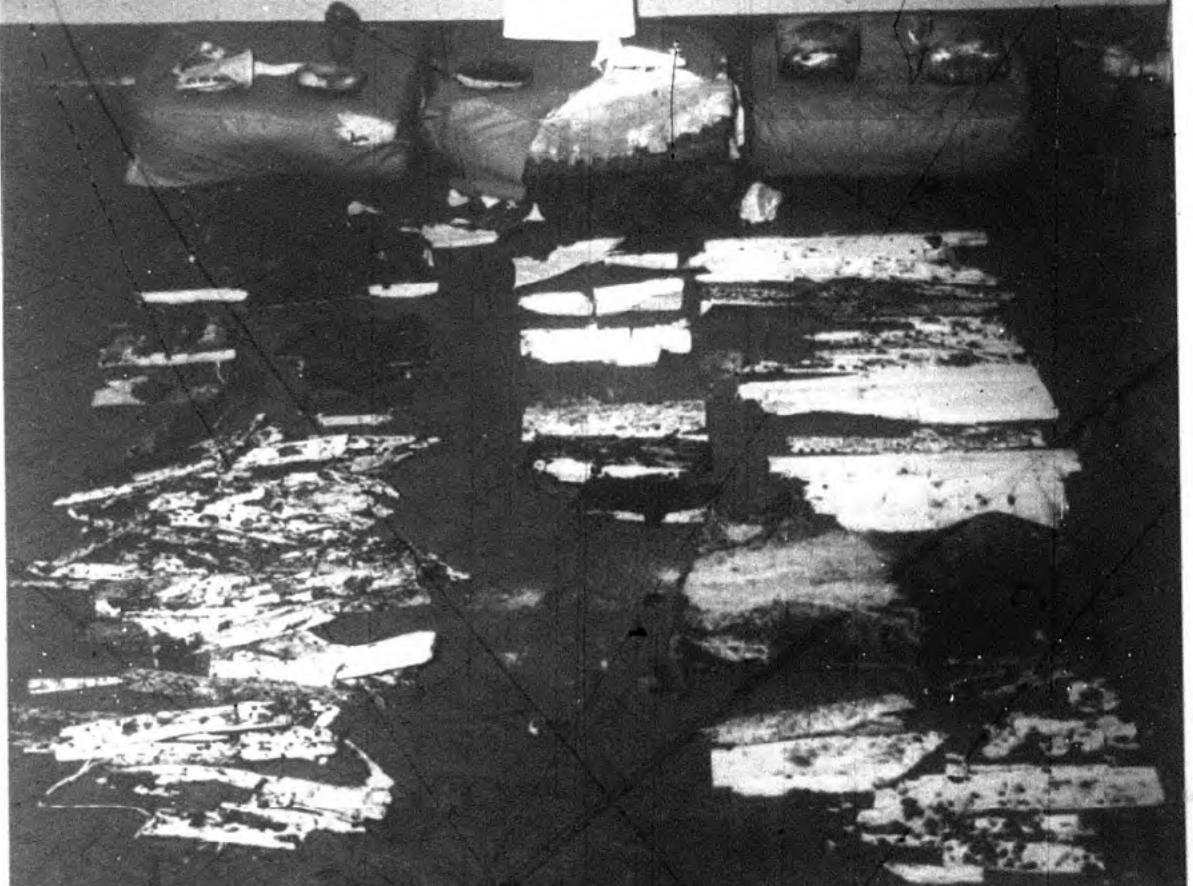
C  
SNC 5 39908 18 SEPT 1958  
DEBRIS RECOVERED  
ENCLOSURE (3) PAGE 1

1. The balsa wood decking was shattered into many small pieces indicating high impact forces.
2. The seat cushions were ripped.

b. The shattered condition and considerable number of small balsa-wood pieces recovered indicates the likelihood of an uncontrolled crash rather than a controlled water landing.

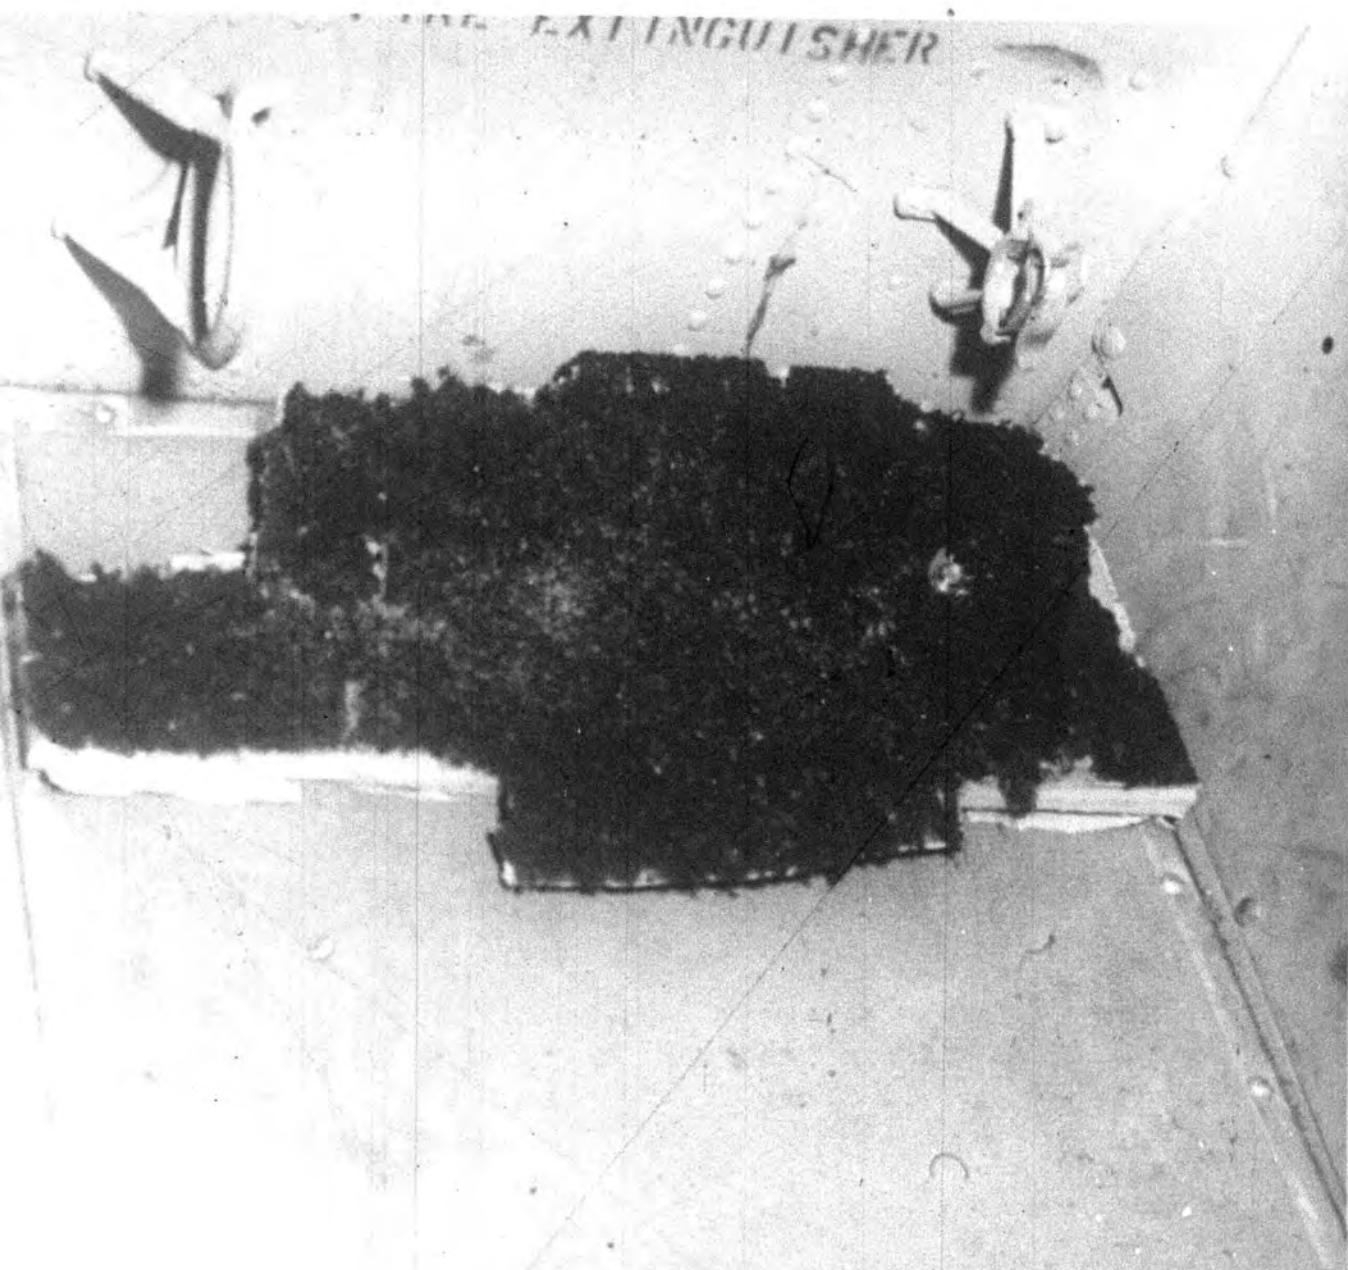
ENCLOSURE(S) PAGE 2

SNB 5 39908 18 Sept 1958  
LEFT REAR CORNER OF DECK WITH  
SNAP FASTENER

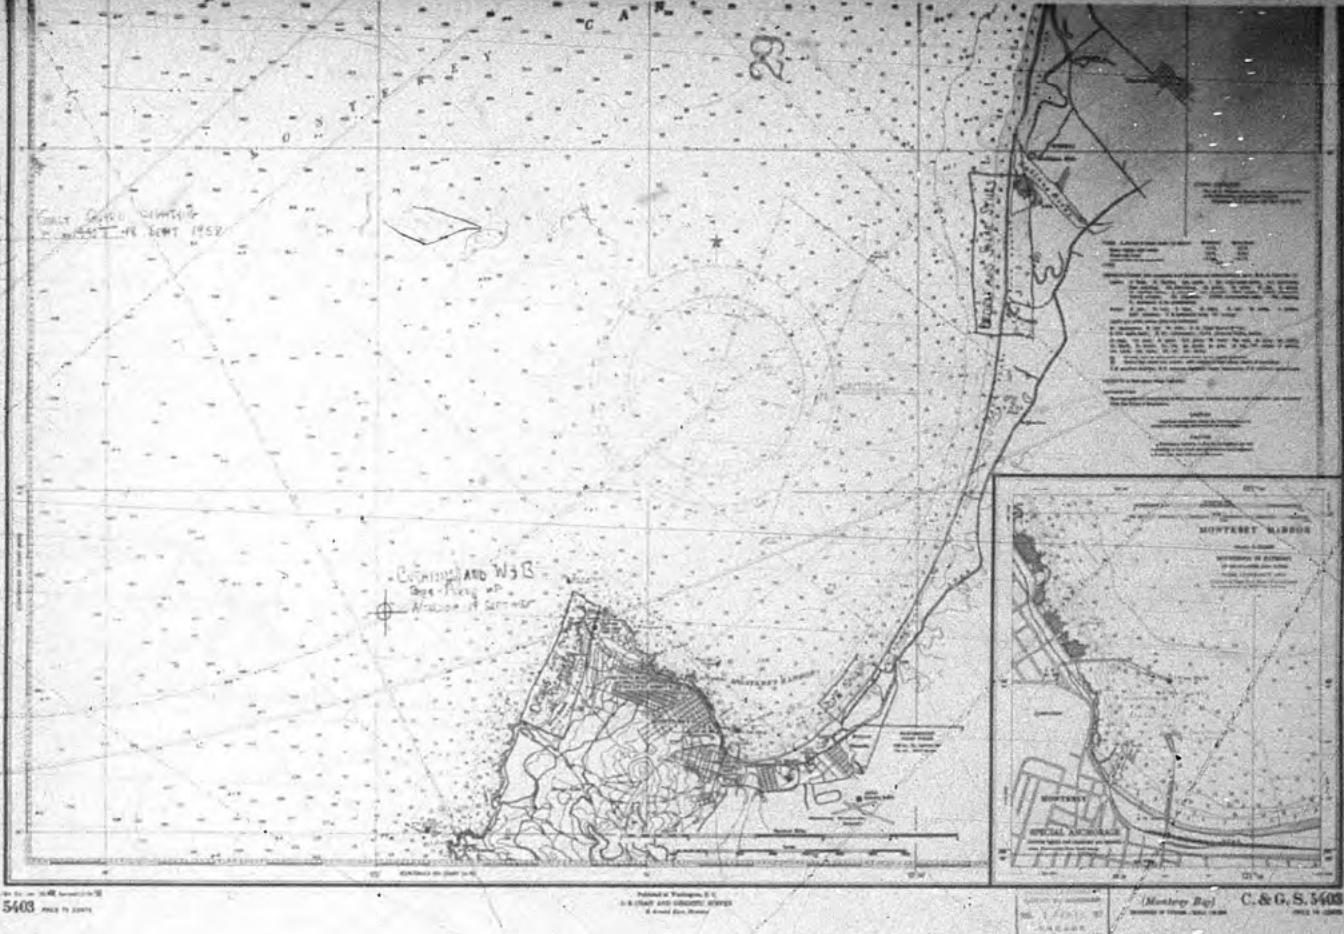
m. Walking searches during the week collected a considerable amount of decking, two solar stills, and a dye marker. A large amount of the debris was collected between the PT. Ord danger area and the Salinas river. (ENCLOSURE 3)

DIAGRAM OF SIGHTINGS AND DEBRIS RECOVERIES  
ENCLOSURE (3) PAGE 7
